Manhole Inspection Summary

Manhole # S31M__007MH

Insp Date: **12/26/08 10:46 AM**

Location Address: **617 Burgandy St**

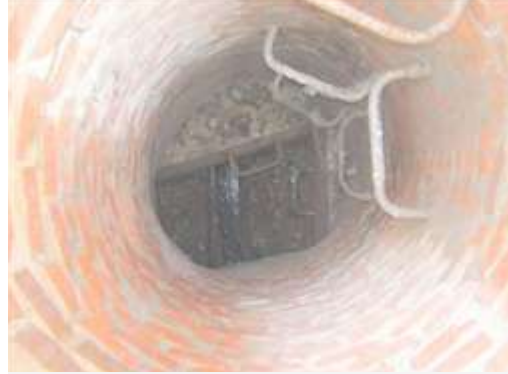
Top View

connection @ 3 oclock is obscured by MH shelf, see Miscellaneous pics

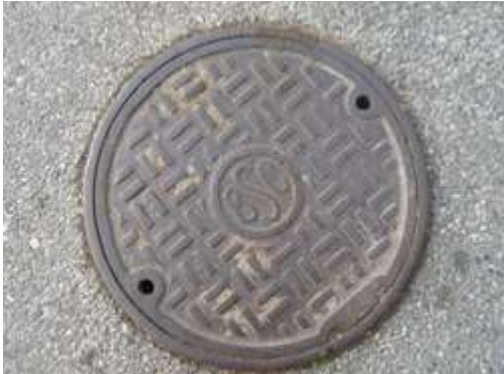
Miscellaneous

MH cover

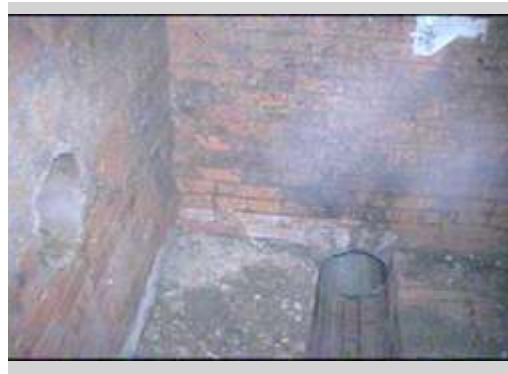
Miscellaneous

view at 6 OClock inlet under flat top

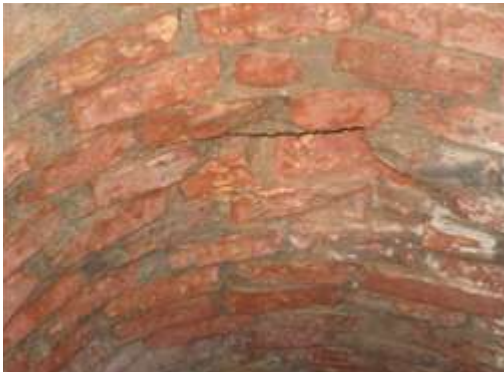
Defect 4

Condition: ☐ Sound ☒ **Cracked** ☐ Root Intrusion ☐ Loose Brick ☒ **Deteriorated**

Infiltration: ☐ None ☐ Joint ☐ Cracks ☒ **Mortar** ☐ Roots ☒ **Wall**

corbel cracked & deteriorated bricks

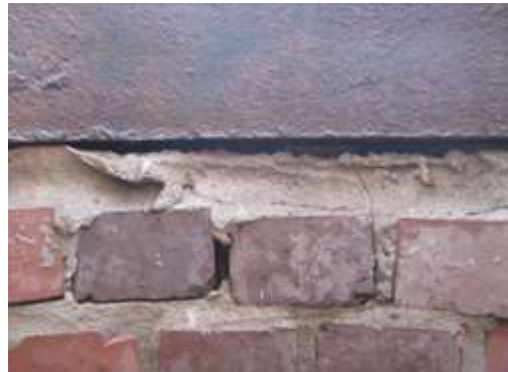
Defect 3

Condition: ☐ Sound ☐ Cracked ☐ Root Intrusion ☒ **Loose Brick** ☐ Deteriorated

chimney loose bricks under frame, deteriorated

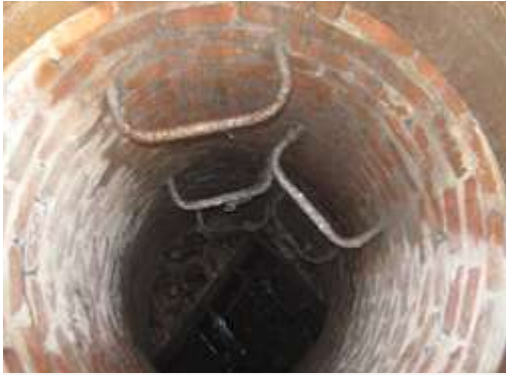
Defect 2

Infiltration: ☐ None ☒ **Joint** ☐ Cracks ☒ **Mortar** ☐ Roots ☒ **Wall**

Count: **8** Missing: **0** ☒ **Corroded**

chimney infiltration from wall, joint, & mortar; corbel infiltration from mortar & wall; steps corroded

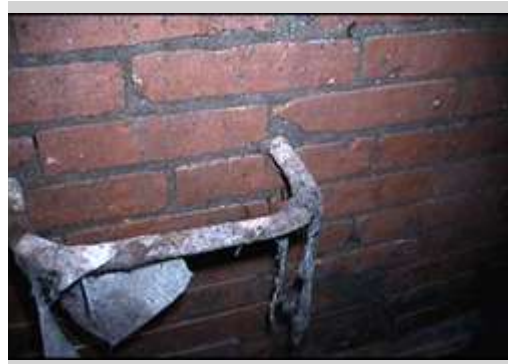
Defect 1

☒ **Evidence Of Surcharge** Depth: **4** (ft.) ☐ Active Surcharge Present

surcharge evidence 4 feet

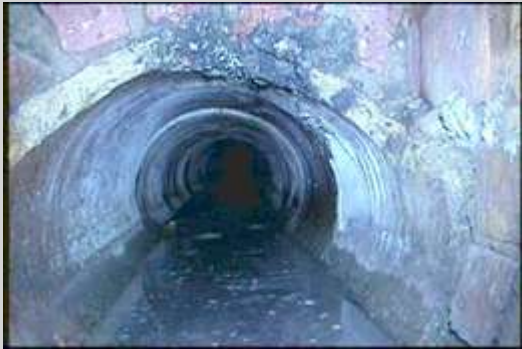
12 O'Clock Outflow

Pipe Height: **10.8** (in.) Rod and Bar (Angled)
Pipe Material: **Clay** ☐ Pipe Lined
Invert Depth: **13.44** (ft.) Flow Characteristics: **Fast**
Deposits: ☒ None ☐ Mud ☐ Sludge ☐ Debris ☐ Grease
Silt Depth: **0** (in.) Deposits Extent:
Infiltration: **None** Pipe Seal Cond: **Sound**

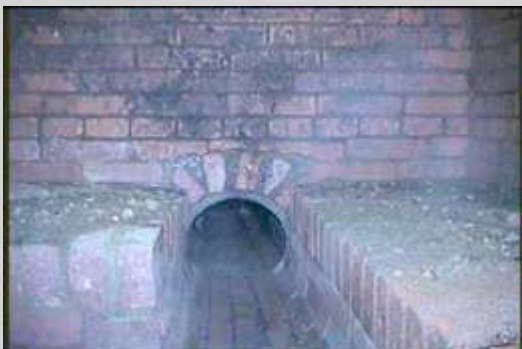
3 O'Clock Inflow

Pipe Height: **3.6** (in.) Direct (Angled)
Pipe Material: **Clay** ☐ Pipe Lined
Invert Depth: **8.00** (ft.) Flow Characteristics: **Slow**
Deposits: ☒ None ☐ Mud ☐ Sludge ☐ Debris ☐ Grease
Silt Depth: **0** (in.) Deposits Extent:
Infiltration: **None** Pipe Seal Cond: **Sound**

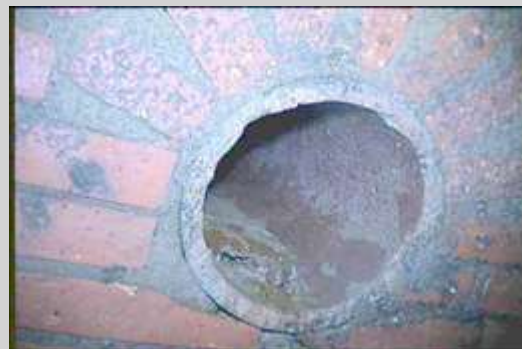
Pipe In @ 3 O'Clock

Drop: **Outside Direct**
Angled: **Yes** Reading: **0.00** (ft.)
Inv Depth: **12.96** (ft.)
Drop Condition: **Open**

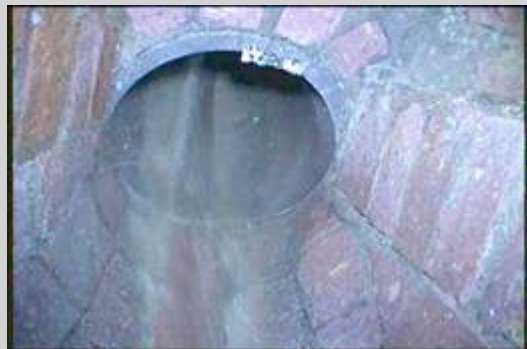
6 O'Clock Inflow

Pipe Height: **0** (in.) Direct

Invert Depth: **12.94** (ft.) Flow Characteristics: **Fast**

Infiltration: **None** Pipe Seal Cond: **Sound**
